# Manhole Inspection Summary

Manhole # S35K\_\_003MH

Insp Date: **7/9/09 10:45 AM**

**Location** Address: **300 S. Charles St**

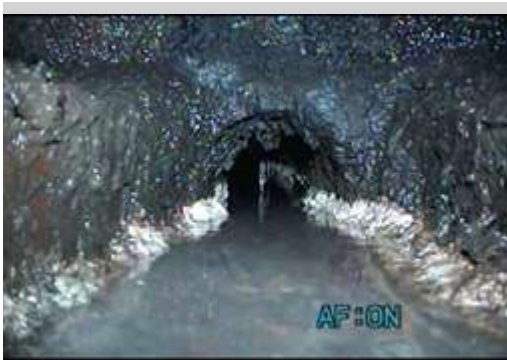
Defect 7

deteriorating channel

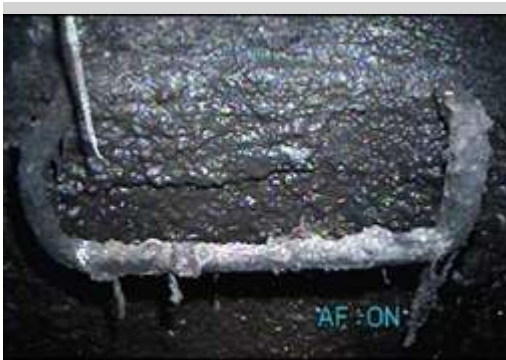
Defect 2

corroded steps; evidence of surcharge

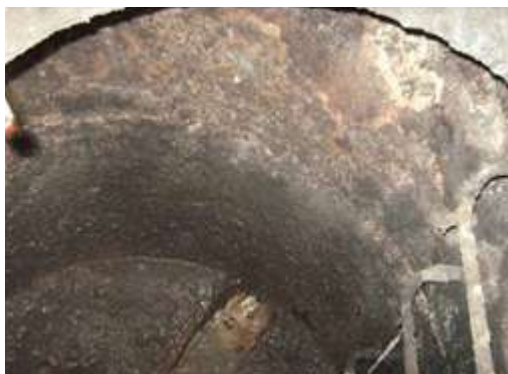
Defect 6

signs of infiltration on barrel wall

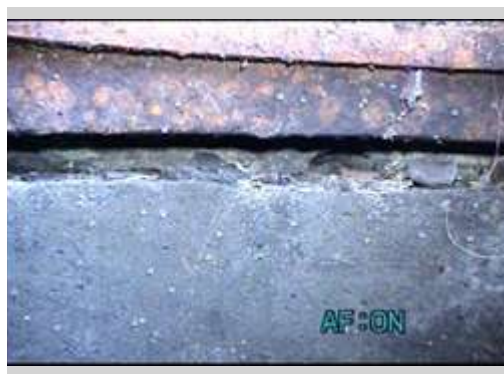
Defect 5

deterioration under frame...2" gap at the chimney/ frame joint

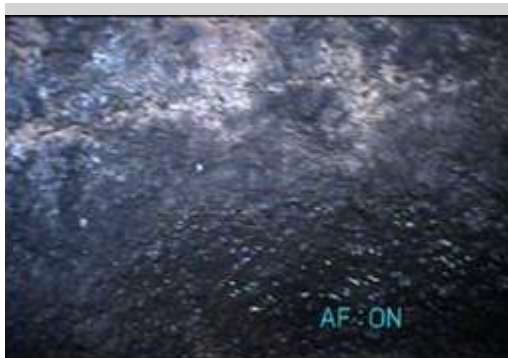
Defect 4

mold on corbel wall

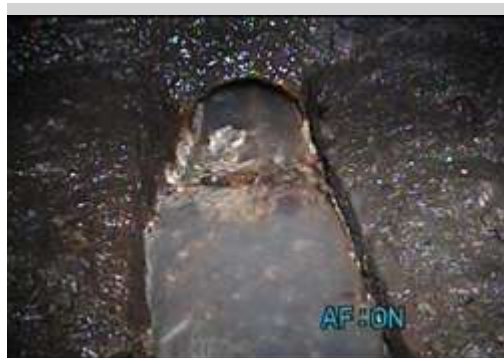
Defect 3

debris in channel

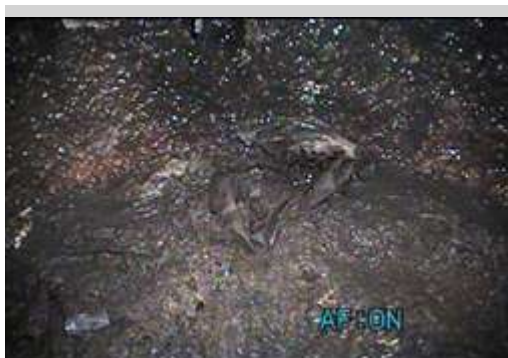
Defect 1

debris on bench, deteriorating bench and barrel

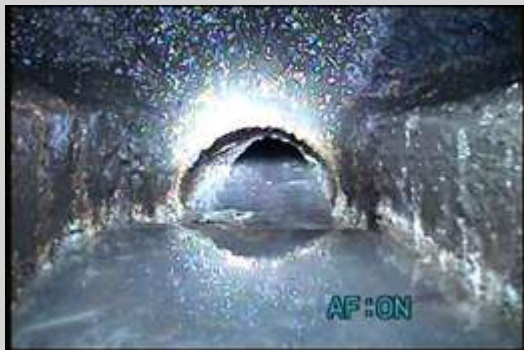
12 O'Clock Outflow

Pipe Height: **6** (in.) Rod and Bar (Angled)  
Pipe Material: **Clay** ☐ Pipe Lined  
Invert Depth: **6.08** (ft.) Flow Characteristics: **Slow**  
Deposits: ☐ None ☐ Mud ☒ **Sludge** ☐ Debris ☐ Grease  
Silt Depth: **1** (in.) Deposits Extent: **Light**  
Infiltration: **None** Pipe Seal Cond: **Unknown**

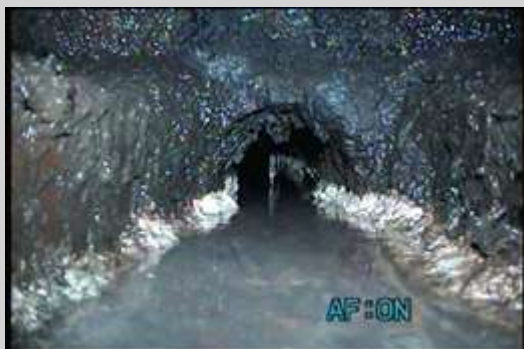
6 O'Clock Inflow

Pipe Height: **6** (in.) Rod and Bar (Angled)  
Pipe Material: **Clay** ☐ Pipe Lined  
Invert Depth: **6.02** (ft.) Flow Characteristics: **Slow**  
Deposits: ☐ None ☐ Mud ☒ **Sludge** ☐ Debris ☐ Grease  
Silt Depth: **1** (in.) Deposits Extent: **Light**  
Infiltration: **None** Pipe Seal Cond: **Unknown**
